Coastal protection from an air-handling perspective

David Livingstone, a Chartered Engineer, and the managing director of DRLC, Consulting Engineers, discusses some of the key considerations for healthcare engineers to ensure that the performance of air-handling units in hospitals located in coastal areas is not compromised by corrosion created by the increased concentration of salt in the local atmosphere.

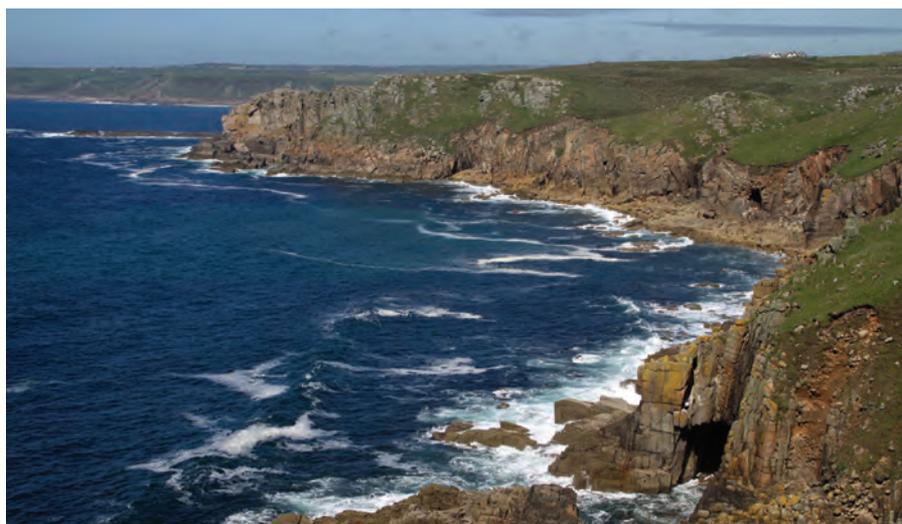
The Cornish coastline. There are potential risks to both the fabric and plant and equipment of hospitals located in close proximity to the sea, due to the increased concentration of salt in the atmosphere.

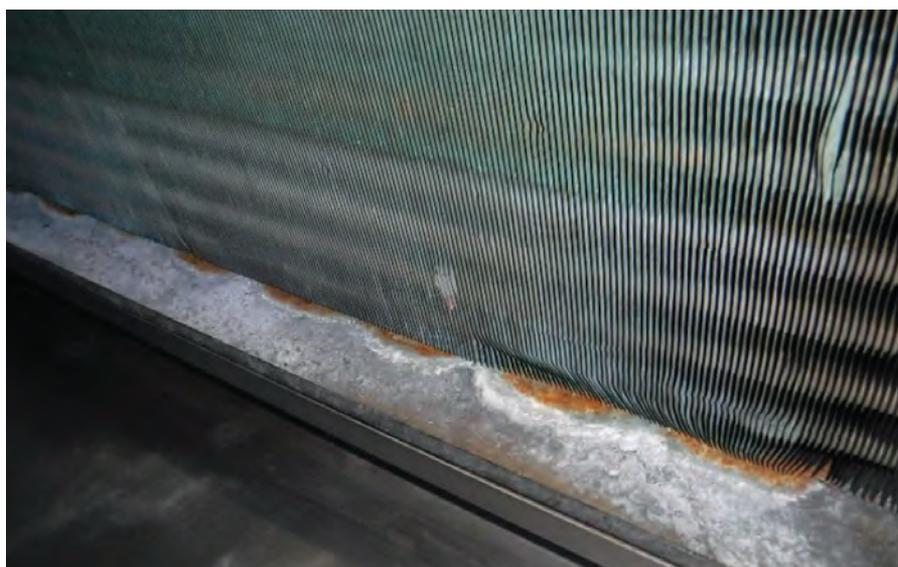
Figure 2: Rust at the base of a frost/fog coil.

In a coastal area, where sea salt is in the air, pre-heating the incoming air by using the frost coil as a fogging coil to reduce the humidity will effectively remove the effects of the airborne salt in the first section of the AHU. However, this means that the salt-laden air has travelled through the air intake and vermin grille, through the attenuator, over the motorised damper, and past the fog coil, before it hits the first panel filter. Thus these parts of the AHU will inevitably be exposed to salt-laden air, and are liable to increased corrosion when located in a coastal area – particularly the ducting of the AHU, and the casing of the fog coil (see Fig 2).

Rust at the base of a frost/fog coil
